Manhole Inspection Summary

Manhole # S27S__016MH

Location Address: **1620 Bush ST**

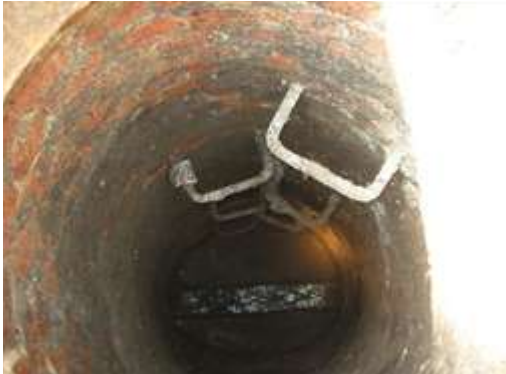
Defect 7

Infiltration: ☐ None ☐ Joint ☐ Cracks ☐ Mortar ☐ Roots ☒ **Wall**

signs of infiltration at corbel and barrel

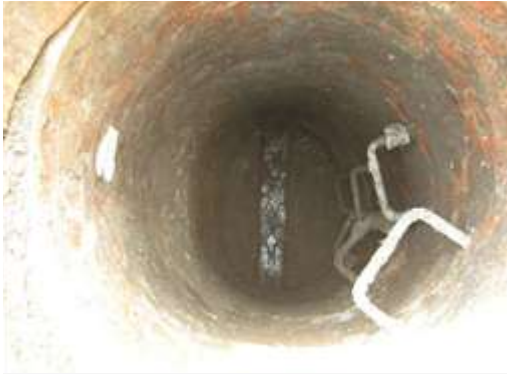
Defect

Frame Offset: **3** (in.) Condition: ☒ Sound ☐ Cracked ☐ Leaks

Frame Offset

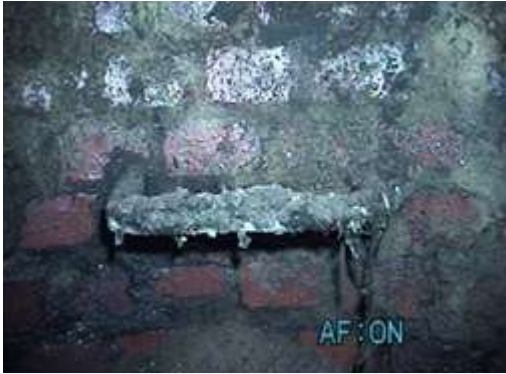
Defect 4

Surcharge ☒ **Evidence Of Surcharge** Depth: **9.5** (ft.) ☐ Active Surcharge Present

SIGNS OF SURCHARGE

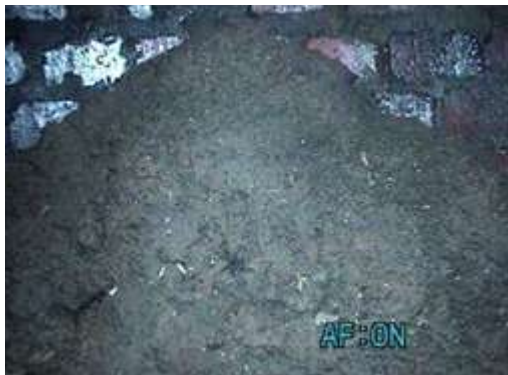
Defect 3

Condition: ☐ Sound ☐ Cracked ☐ Root Intrusion ☐ Deteriorated ☐ Leaks ☒ **Debris**

DEBRI ON BENCH

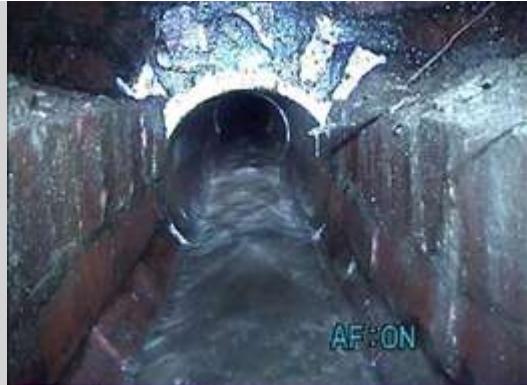
12 O'Clock Outflow

Pipe Height: **10.8** (in.) Rod and Bar (Angled)
Pipe Material: **Clay** ☐ Pipe Lined
Invert Depth: **13.44** (ft.) Flow Characteristics: **Fast**
Deposits: ☒ None ☐ Mud ☐ Sludge ☐ Debris ☐ Grease
Silt Depth: **0** (in.) Deposits Extent:
Infiltration: **Evidence** Pipe Seal Cond: **Unknown**

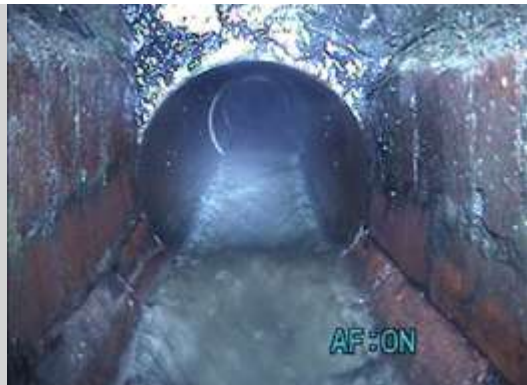
6 O'Clock Inflow

Pipe Height: **10.8** (in.) Rod and Bar (Angled)
Pipe Material: **Clay** ☐ Pipe Lined
Invert Depth: **13.48** (ft.) Flow Characteristics: **Fast**
Deposits: ☒ None ☐ Mud ☐ Sludge ☐ Debris ☐ Grease
Silt Depth: **0** (in.) Deposits Extent:
Infiltration: **Evidence** Pipe Seal Cond: **Unknown**
